# HOME INSPECTION REPORT

# Inspection Detail Report

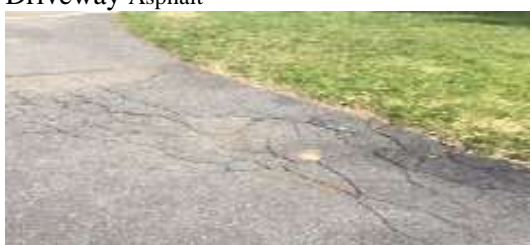
<b>Driveway</b> ..	<b>S M P</b>	RE – There is evidence of cracks to the asphalt driveway.
8) Driveway Asphalt

<input type="checkbox"/> <input checked="" type="checkbox"/> <input type="checkbox"/>	Recommend repair and sealing by a qualified driveway contractor.  ME- Asphalt driveway surfaces require ongoing maintenance and should be sealed every 2-4 years.

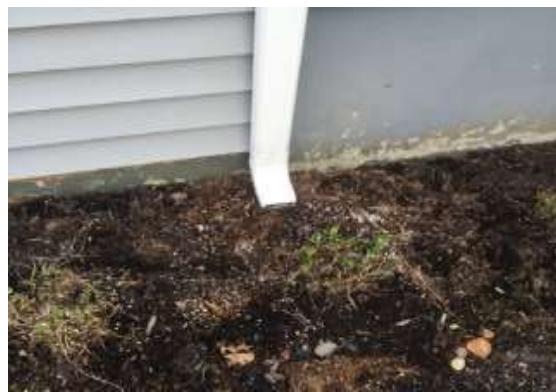
18) Splash Plates and Extensions .	<input type="checkbox"/> <input checked="" type="checkbox"/> <input type="checkbox"/>

RE - Recommend adding splash plates and extensions to the gutter downspouts in order to keep water away from the house and from penetrating foundation.

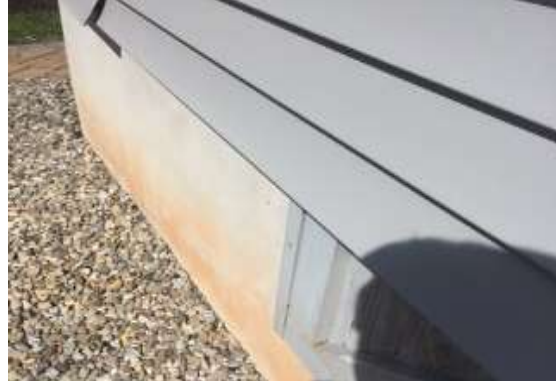
RE- There are a few sections of loose vinyl siding above the rear entrance to the crawl space. Needs repair/securing by a qualified contractor to prevent potential damage.

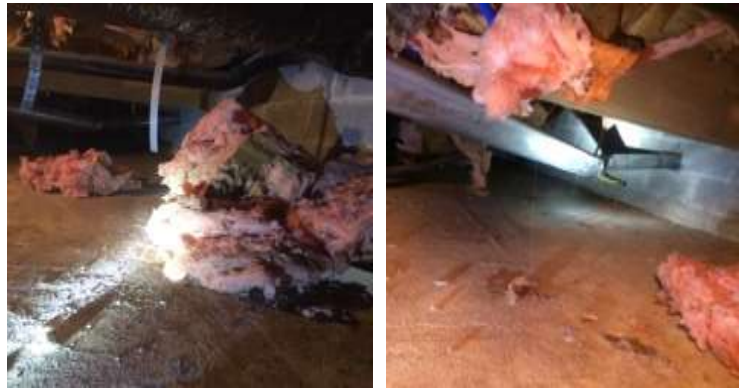
RS- Some of the insulation has fallen out from between the floor joists in the rear crawl space. Needs repair/new insulation added for energy efficiency.

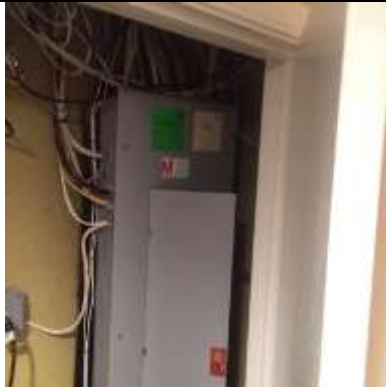
<p>RS - There is not enough clearance across the front of the main electrical panel in the basement. Standards require 3-ft across the front of panel for safety. Needs repair/clearance added by a qualified contractor.</p>

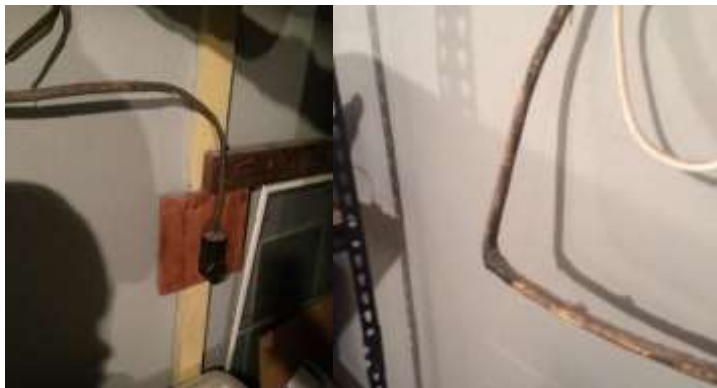
<p>RS- There are two old electrical wires in the rear basement for a prior electric dryer hook up. Recommend shutting off the breakers to these wires or having them removed for safety.</p>

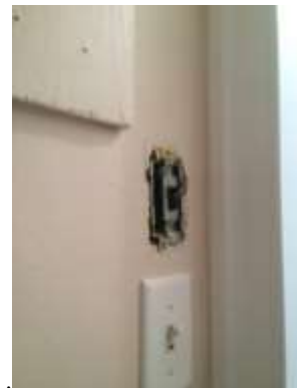
<p>RS – The red metal cover is missing to the emergency shut off switch at the top of the basement stairs. Needs repair/cover added.</p>

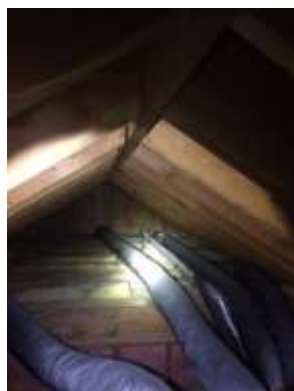
RS- There is one PVC plumbing vent that is disconnected in the rear attic and should extend through the roof line to vent outside. Needs repair by a licensed plumber for proper venting.
