HOME INSPECTION

INSPECTION REPORT

Roost Home Inspection

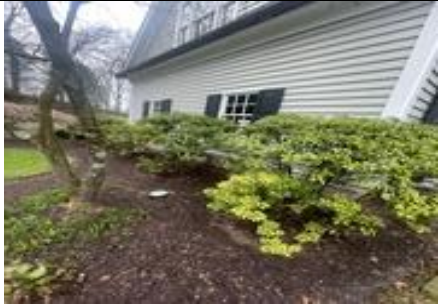
Trim or remove all vegetation, vines, bushes, and branches that touch, grow, or excessively shade the walls, foundation, roof, or chimney to prevent possible insect intrusion and physical damage to the structure. There was a limited view of the structure and components beneath the excessive vegetation. Needs repair and further evaluation by qualified contractors for safety.

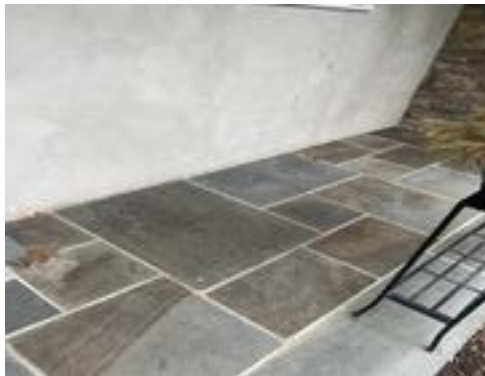
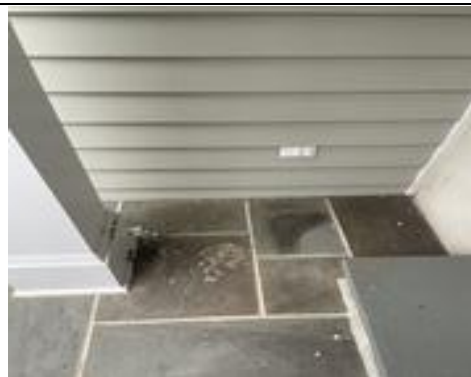
- 4) Grading/touching siding
☐ Soil/Mulch ☐ Stone ☒ Porch ☐ Walkway

9. The siding is improperly in contact with the front left-side porch. This condition can allow insects/moisture to enter behind the siding and prematurely damage siding/components without visual detection. Needs further evaluation and repair by qualified contractors for safety.

The siding is improperly in contact with the front left-side porch. This condition can allow insects/moisture to enter behind the siding and prematurely damage siding/components without visual detection. Needs further evaluation and repair by qualified contractors for safety.

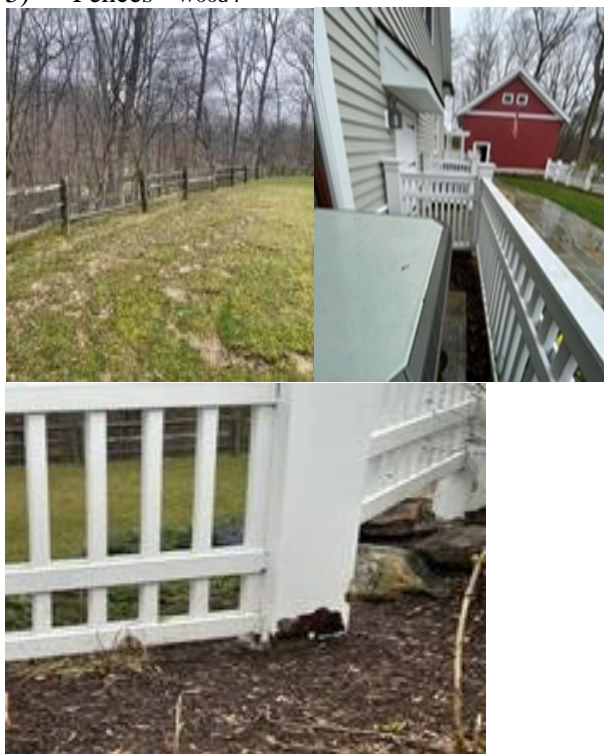
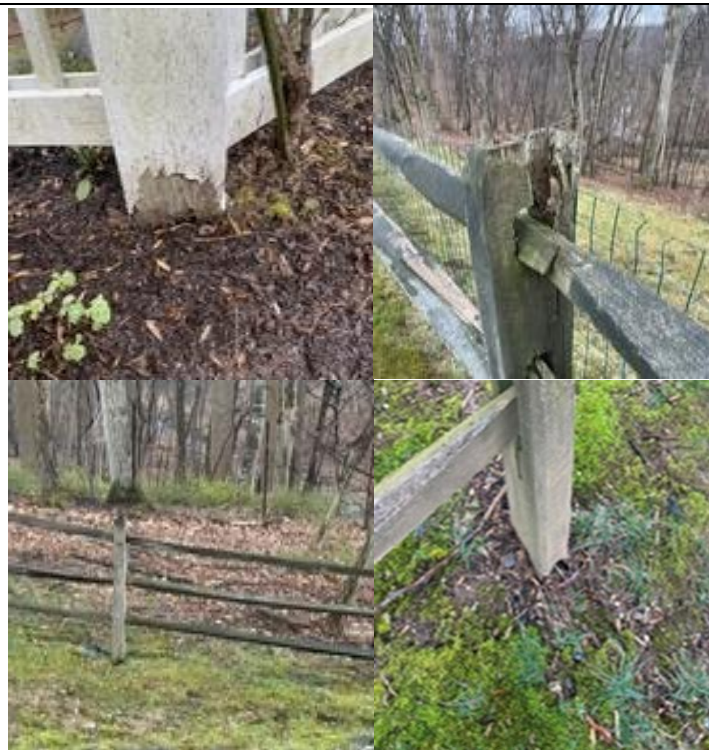
- 5) Fences Wood .

6. The exterior wood fence/s are in overall poor condition. The issues include but are not limited to: Water rot to wood fence components throughout including the patio pergola, termite damage to many of the wood fence posts, leaning sections of wood fence, and the fence/s around the AC condensers lack a gate for proper entrance. Needs further evaluation and repairs or replacements by a qualified contractor for safety.

The exterior wood fence/s are in overall poor condition. The issues include but are not limited to: Water rot to wood fence components throughout including the patio pergola, termite damage to many of the wood fence posts, leaning sections of wood fence, and the fence/s around the AC condensers lack a gate for proper entrance. Needs further evaluation and repairs or replacements by a qualified contractor for safety.

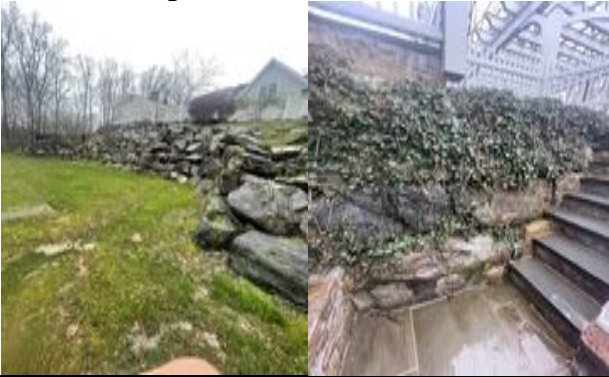
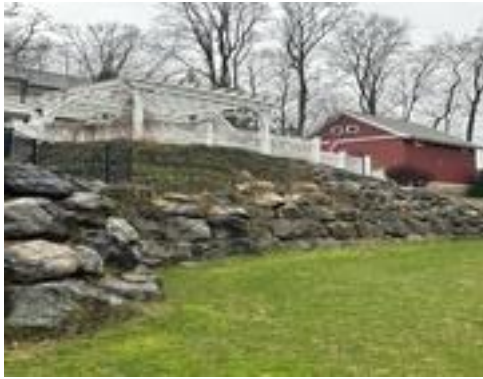
Landscape Walls		S	M	P	
7)	Retaining Wall Stacked Stone	<input type="checkbox"/>	<input checked="" type="checkbox"/>	<input type="checkbox"/>

<p>Some of the landscape retaining walls are composed of stacked stones of various sizes. Many areas are covered with vegetation and not fully visible. These walls will require regular maintenance including restacking stones periodically. Monitor and repair as necessary.</p>

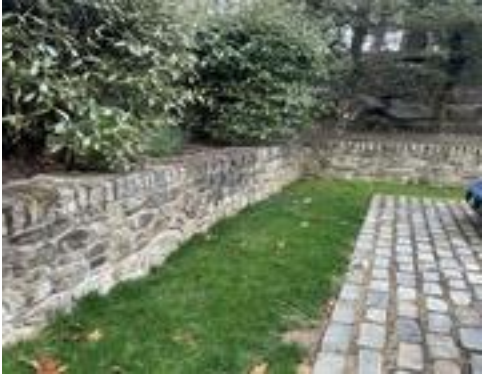
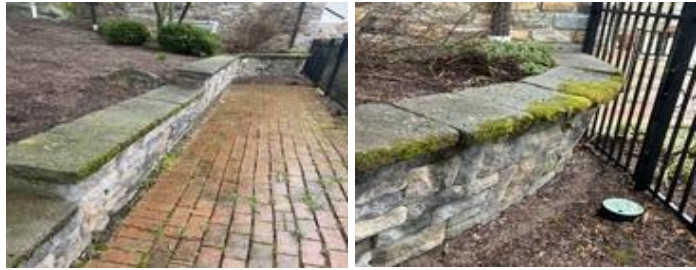
8)	Retaining Wall Paver	<input type="checkbox"/>	<input type="checkbox"/>	<input checked="" type="checkbox"/>

8. The paver retaining wall in the rear of the home is visibly leaning. Needs further evaluation and repair or replacement by a qualified contractor for safety.

<p>The paver retaining wall in the rear of the home is visibly leaning. Needs further evaluation and repair or replacement by a qualified contractor for safety.</p>

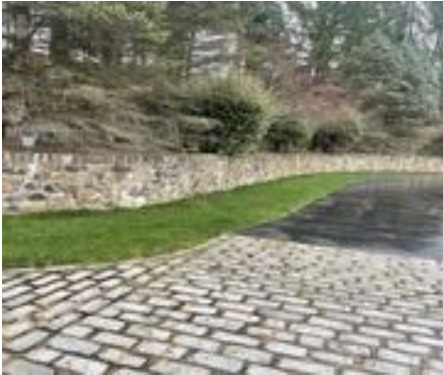
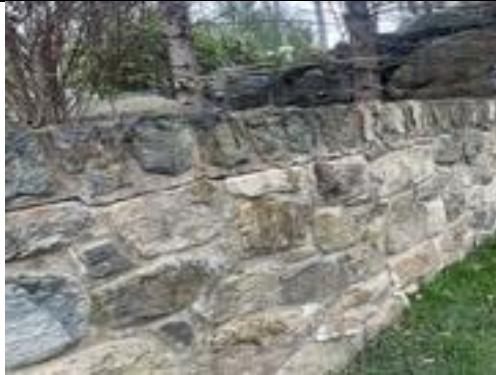
4. There is a horizontal crack running through a large section of the driveway retaining wall. Needs further evaluation and repair by a qualified contractor for safety.

<p>There is a horizontal crack running through a large section of the driveway retaining wall. Needs further evaluation and repair by a qualified contractor for safety.</p>

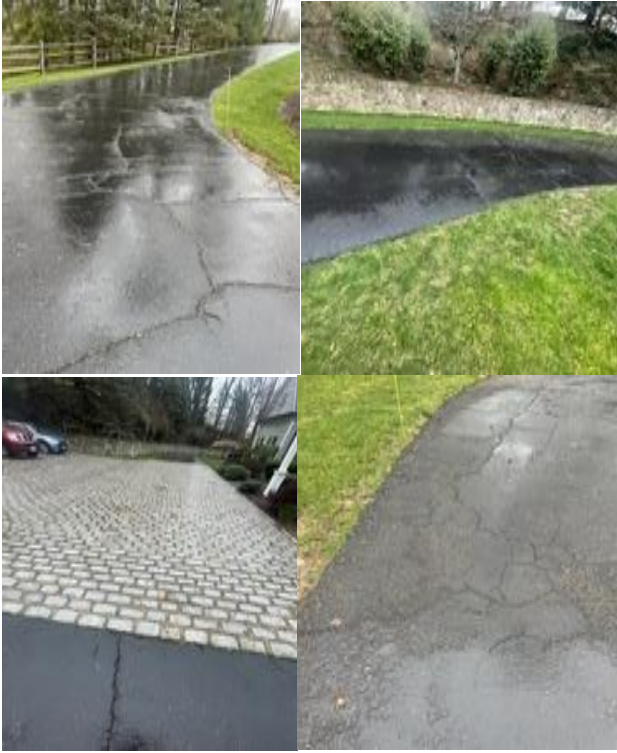
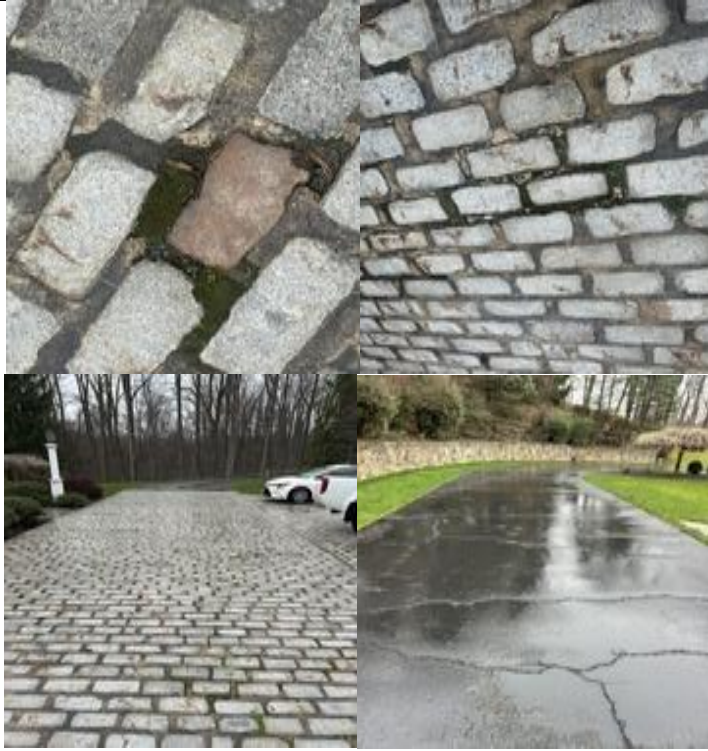
Driveway .. 37) Driveway Asphalt/Stone/Concrete ..

3. There are multiple issues regarding the driveway. The issues include but are not limited to: Cracking/deterioration to the asphalt portion of the driveway throughout and cracking/spalling to mortar joints between the stone portion of the driveway throughout. Needs further evaluation and repairs or replacements by a qualified driveway contractor for safety.

There are multiple issues regarding the driveway. The issues include but are not limited to: Cracking/deterioration to the asphalt portion of the driveway throughout and cracking/spalling to mortar joints between the stone portion of the driveway throughout. Needs further evaluation and repairs or replacements by a qualified driveway contractor for safety.
Garage 3 Doors 38) <input checked="" type="checkbox"/> Attached <input type="checkbox"/> Not Fully Inspected 39) Interior

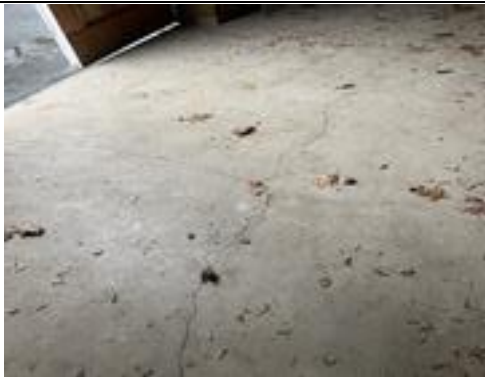
5. There is cracking to the detached concrete garage floor. Needs further evaluation and repair by a qualified mason contractor for safety.

There is cracking to the detached concrete garage floor. Needs further evaluation and repair by a qualified mason contractor for safety.

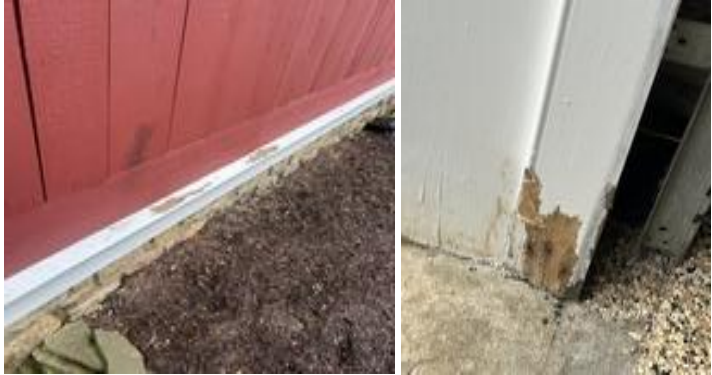
24. There are several issues regarding the detached garage wood exterior siding and associated components. The issues include but are not limited to: visual water rot damage, holes, flaking paint and wood rot throughout. Needs further evaluation and repairs or replacements by a qualified siding contractor for safety. Additionally, recommend recaulking around all windows, doors, trim, and other penetrations in the exterior siding.
25. There is a vent cap missing form a PVC pipe exiting from the rear stone siding by the pool area. Needs repair by a qualified contractor for safety.

There are several issues regarding the detached garage wood exterior siding and associated components. The issues include but are not limited to: visual water rot damage, holes, flaking paint and wood rot throughout. Needs further evaluation and repairs or replacements by a qualified siding contractor for safety. Additionally, recommend recaulking around all windows, doors, trim, and other penetrations in the exterior siding.

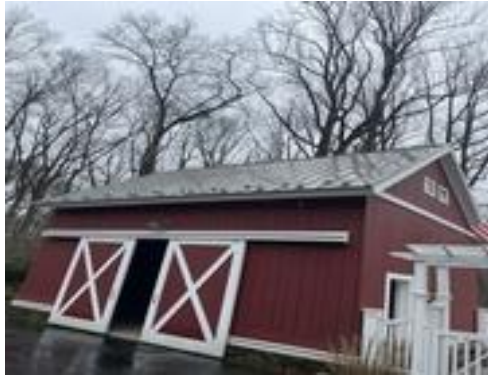
2. The detached garage metal roof appears to be an older metal roof installation. Recommend monitoring for leaks and repair or replace as needed. Recommend obtaining a copy of all related paperwork associated with this installation, including permits, contracts, receipts, warranties (including manufactures shingles).

The detached garage metal roof appears to be an older metal roof installation. Recommend monitoring for leaks and repair or replace as needed. Recommend obtaining a copy of all related paperwork associated with this installation, including permits, contracts, receipts, warranties (including manufacturer's shingles).

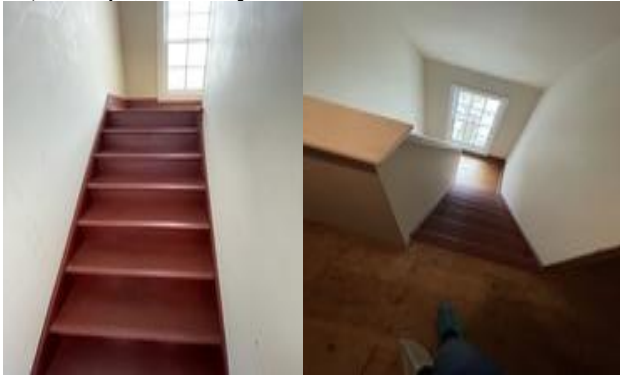
29. The handrails are missing from the stairs leading to the garage and attic. Standards require a handrail on both sides of steps 40 inches wide and 3 or more risers. Needs handrails added by a qualified contractor for safety.

<p>The handrails are missing from the stairs leading to the garage and attic. Standards require a handrail on both sides of steps 40 inches wide and 3 or more risers. Needs handrails added by a qualified contractor for safety.</p>
Interior Stairs		S M P

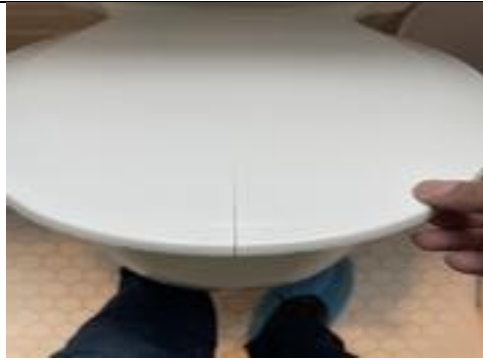
<p>The 2nd Floor Full bathroom toilet seat is cracked/damaged. Additionally, the toilet could not be fully tested or evaluated as the water was shut off to the toilet. Needs further evaluation and repairs or replacement by a licensed plumber for safety.</p> <p>Recommend re-caulking perimeter of the bathtub/shower, spout, and diverter in the 2nd Floor Full bathroom to prevent water intrusion and leaking. Needs repair by a qualified contractor for safety.</p> <p>The 2nd Floor Full bathroom tub drain stop is broken. Needs repair or replacement by a licensed plumber for safety and proper function.</p>

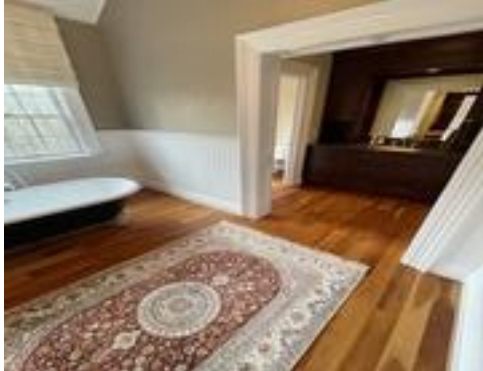
<p>The Master bathroom sink faucet has low water pressure. Needs further evaluation and repair or replacement by a licensed plumber for safety.</p> <p>The Master bathroom shower pan is incorrectly pitched allowing water to pool and not move towards the drain. Needs further evaluation and repair or replacement by a qualified contractor for safety.</p> <p>The diverter on the tub in the Master bathroom was not functioning. Water could not be diverted to the tub sprayer. Needs further evaluation and repair or replacement by a licensed plumber for safety.</p>

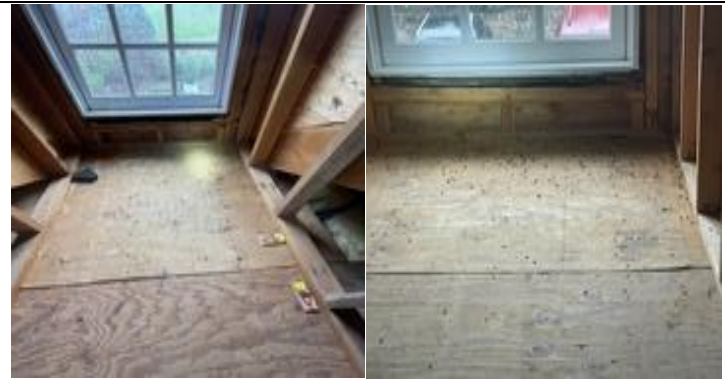
There is rodent, wasp and ladybug activity throughout the attic space. Needs further evaluation and remediation by a qualified pest control contractor for safety.

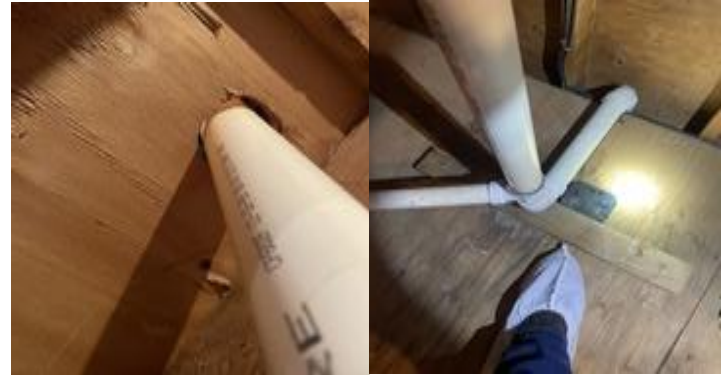
32. There is visible water staining on areas of the roof sheathing and on the floor beneath the plumbing vents and chimney flashings. Areas appeared dry when evaluated and the leaks appear to have come from the roof/around plumbing and chimney flashings. Needs further evaluation and repairs or replacements by a qualified roofing contractor for safety.

There is visible water staining on areas of the roof sheathing and on the floor beneath the plumbing vents and chimney flashings. Areas appeared dry when evaluated and the leaks appear to have come from the roof/around plumbing and chimney flashings. Needs further evaluation and repairs or replacements by a qualified roofing contractor for safety.

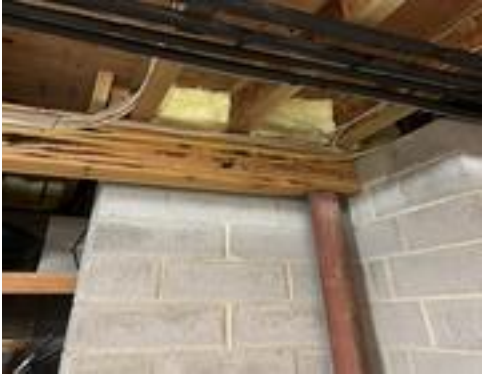
<input type="checkbox"/>	<input type="checkbox"/>	<input type="checkbox"/>	<p>There are rodent droppings, dead rodents, and rodent activity in the basement. Needs further evaluation and remediation by a qualified pest control contractor for safety.</p> <p>There is a vertical crack in the foundation wall near the central vacuum system. Needs further evaluation and repair, if necessary, by a qualified mason contractor for safety.</p>

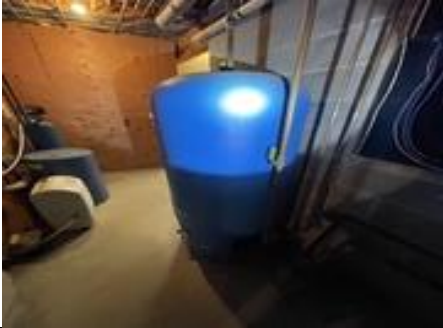
<p>The Heating System is older and at the manufactures life expectancy. The unit was functioning at the time of inspection. All units should be serviced, certified and put on an annual service/repair contract with a licensed HVAC contractor. Budget for a replacement when needed.</p> <p>Potable hot water is produced by a tankless coil set into the boiler. It was functioning at the time of inspection.</p>
Plumbing/Pipes Not Fully Visible/Not Fully Evaluated**		S M P

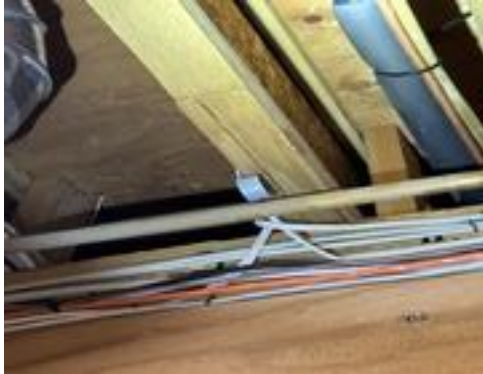
<p>There is a leak on a shutoff valve near the water main in the basement. Needs further evaluation and repair or replacement by a licensed plumber for safety.</p> <p>There is a broken plastic plumbing strap to support the copper water pipe in the front unfinished basement area. Needs repair by a licensed plumber for safety.</p> <p>We did not inspect plumbing waste and associated components. The main sewer pipe exiting the house is underground and not visible or inspected. Note: you are responsible for this pipe and the water main pipe from the street to the house) Recommend having this pipe evaluated/ scoped with a camera by a licensed plumber for safety and condition. Recommend obtaining and maintaining insurance for this pipe which is usually offered by the water company or homeowners' insurance.</p>

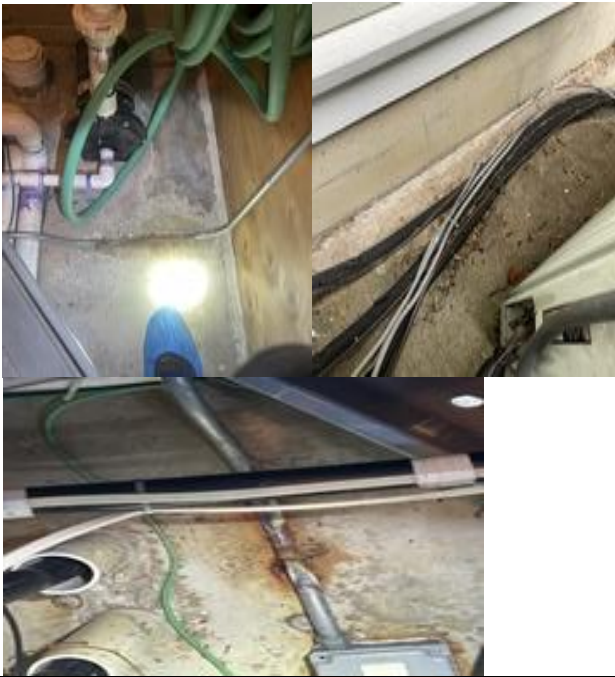
189) Open Junction Box(s) “visible”

38. There are several open junction boxes in the basement. Needs repair, covers added by a licensed electrician for safety.

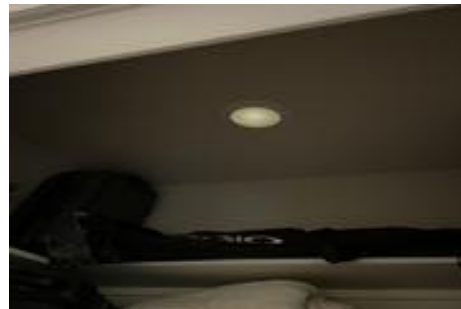
There are multiple issues regarding light fixtures and fans in the home. The issues include but are not limited to: One of the fans in the gym was not functioning when tested, the fan in the master bedroom is rubbing when tested and the light in the 2nd floor hallway closet is extremely dim. Needs further evaluation and repairs or replacement by a licensed electrician for safety.

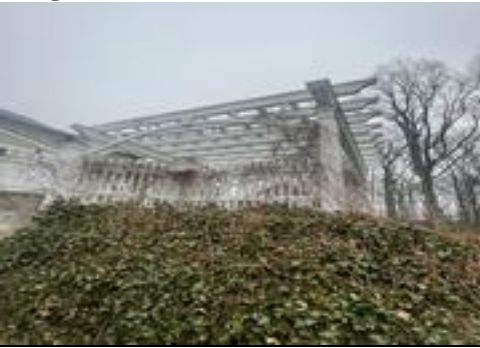
1. The Pergola/like structure was not evaluated. As per the state requirements for home inspection, these structures are not included. However, it was noted that there is damage and wood rot damage. Need further evaluation by a qualified contractor and repair for safety and proper function.

The Pergola/like structure was not evaluated. As per the state requirements for home inspection, these structures are not included. However, it was noted that there is damage and wood rot damage. Need further evaluation by a qualified contractor and repair for safety and proper function.
