# HOME INSPECTION REPORT

# Inspection Detail Report

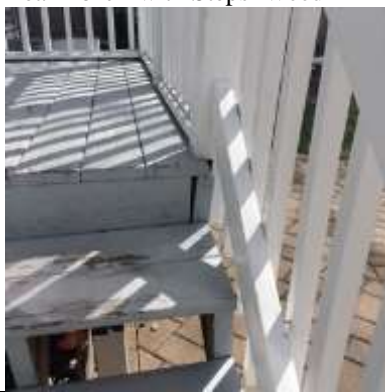
6)	Rear Porch with Steps Wood	<input type="checkbox"/> <input checked="" type="checkbox"/> <input type="checkbox"/>

<p>ME - All wood porches/decks require periodic maintenance and/or repairs. Annual cleaning, repairs &amp; sealing are recommended to prevent water damage and to prolong the porches/decks life.</p> <p>RE- The railing is loose/pulling away from the rear wood porch stairs. Needs repair/securing by a qualified contractor.</p>
