HOME INSPECTION

INSPECTION REPORT

Roost Home Inspection

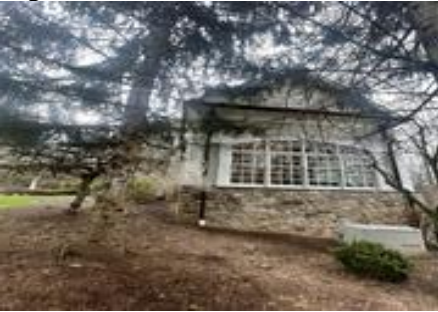
EXTERIOR	RATING	DETAILS
Landscaping	S M P	
1) Vegetation

Trim or remove all vegetation, vines, bushes, and branches that touch, grow, or excessively shade the walls, foundation, roof, or chimney to prevent possible insect intrusion and physical damage to the structure. There was a limited view of the structure and components beneath the excessive vegetation. Needs repair and further evaluation by qualified contractors for safety.

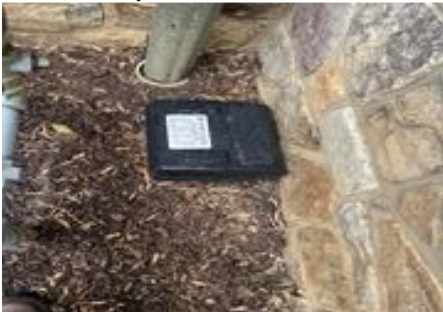
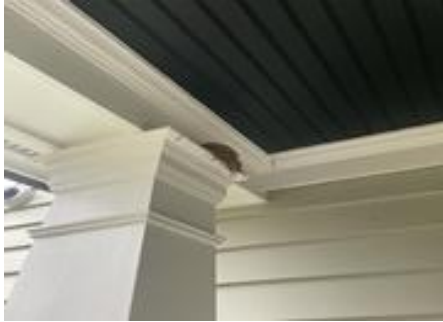
2) Pest (not fully evaluated)

There are rodent traps/rodent activity on the exterior of the home and birds' nests on the home in various areas. Needs further evaluation and remediation by a qualified pest control contractor for safety.

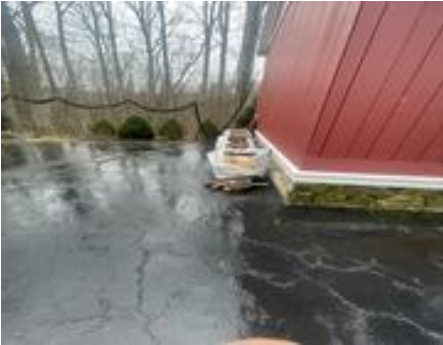
3) Debris

<input type="checkbox"/> <input type="checkbox"/> <input checked="" type="checkbox"/>	 There is stacked wood against the left-side of the exterior garage. Needs proper removal by a qualified contractor for safety and to prevent insect infestation. All stacked firewood should be away from a structure, stored off the ground and covered at the top.

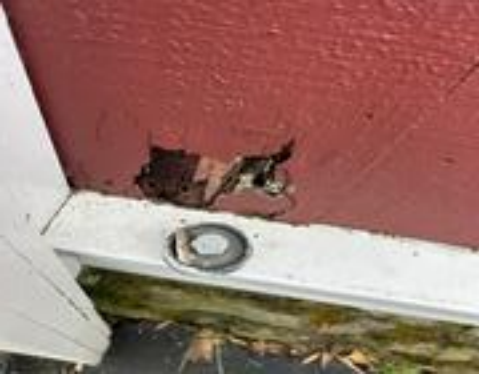
42) Exterior

24. There are several issues regarding the detached garage wood exterior siding and associated components. The issues include but are not limited to: visual water rot damage, holes, flaking paint and wood rot throughout. Needs further evaluation and repairs or replacements by a qualified siding contractor for safety. Additionally, recommend recaulking around all windows, doors, trim, and other penetrations in the exterior siding.
25. There is a vent cap missing form a PVC pipe exiting from the rear stone siding by the pool area. Needs repair by a qualified contractor for safety.

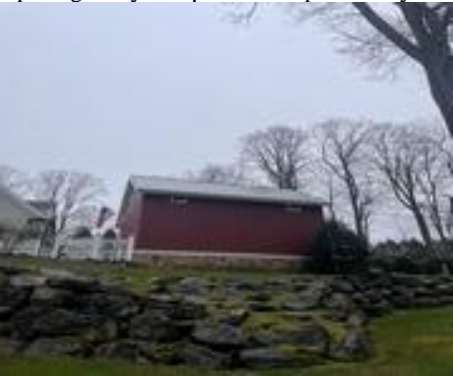
2. The detached garage metal roof appears to be an older metal roof installation. Recommend monitoring for leaks and repair or replace as needed. Recommend obtaining a copy of all related paperwork associated with this installation, including permits, contracts, receipts, warranties (including manufactures shingles).

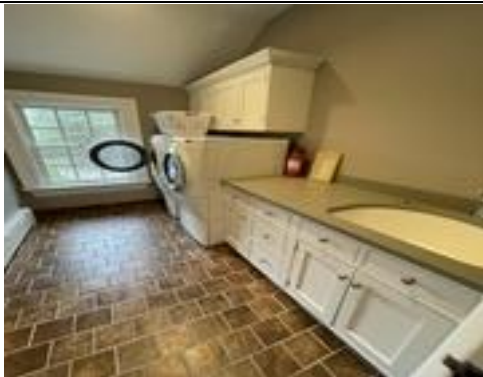
Laundry		S	M	P

<p>The washing machine and dryer are considered personal property and not part of a home inspection. They were not evaluated.</p> <p>Recommend installing Stainless Steel wrapped clothes washer water supply hoses to reduce or eliminate the possibility of bursting.</p>

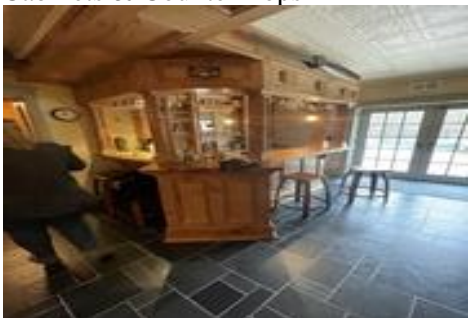
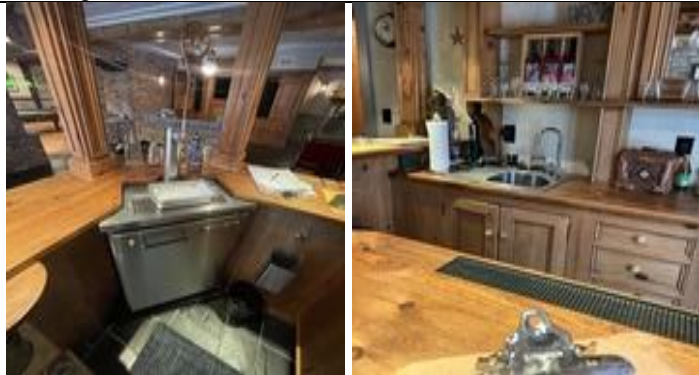
<p>The beer tap/keg in the basement bar was not tested or evaluated. Needs further evaluation by a qualified contractor to determine proper function for safety.</p>

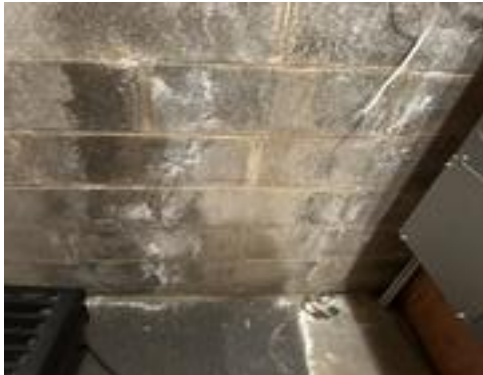
33. There is a vertical crack in the foundation wall near the central vacuum system. Needs further evaluation and repair, if necessary, by a qualified mason contractor for safety.

<input type="checkbox"/>	<input type="checkbox"/>	<input type="checkbox"/>	<p>There are rodent droppings, dead rodents, and rodent activity in the basement. Needs further evaluation and remediation by a qualified pest control contractor for safety.</p> <p>There is a vertical crack in the foundation wall near the central vacuum system. Needs further evaluation and repair, if necessary, by a qualified mason contractor for safety.</p>

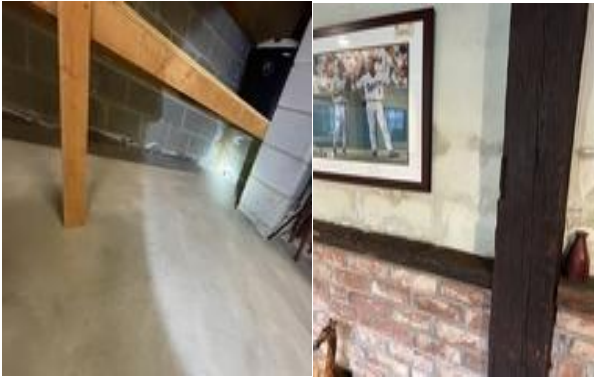
160)	<input checked="" type="checkbox"/> Efflorescence

159)	Water/Moisture: Dry When Inspected	<input checked="" type="checkbox"/>	<input type="checkbox"/>	<input type="checkbox"/>	<p>There is evidence of water penetration issues visible in the Basement. These issues include but are not limited to: Efflorescence on the foundation walls. Needs further evaluation and repair by qualified basement waterproofing contractor for safety. Pin-pointing the origin of the water penetration can be difficult, and usually requires several repairs to eliminate the water penetration issues. These repairs may include the following, but are not limited to:</p> <ul style="list-style-type: none"> • All gutters need to be kept clear to ensure that they properly divert roof surface water. • Any flat/negative areas around the exterior may require re-grading. • All the exterior of the house must be properly sealed. This includes all windows, doors, and the siding materials. • Add a French drain system. • Add a sump pump and pit w/ a battery backup pump to ensure function if the power goes out. Test periodically. • Add DRY LOC paint to the foundation walls. • Add a dehumidifier to help reduce humidity levels during warmer months. • Additional repairs will be needed if these steps do not eliminate the water penetration concerns.

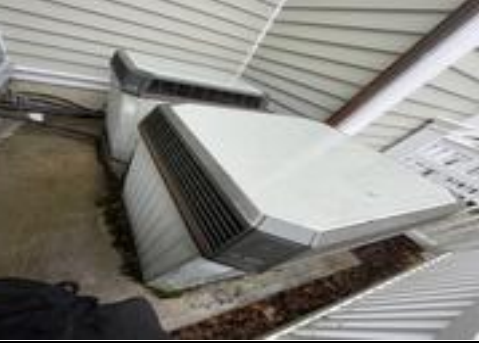
SYSTEMS	RATING	DETAILS	
Air - Conditioning System . .	S M P		
161) . Trane CENTRAL A/C Source electric/split system Size 2.5 tons. Apx. Age 23yrs Apx. Life Exp. 15yrs

162) . Trane CENTRAL A/C Source electric/split system Size 2.5 tons. Apx. Age 23yrs Apx. Life Exp. 15yrs	<input type="checkbox"/> <input type="checkbox"/> <input type="checkbox"/>	<p>The Trane Air Conditioner systems are older and past the manufacture's life expectancy. The units could not be inspected/tested because it was too cold outside. The compressor units cannot be operated when it is below 60 degrees without causing damage. Recommend having all units serviced, certified by a licensed HVAC contractor, and obtaining an annual service/repair contract. Budget for replacements when needed.</p>

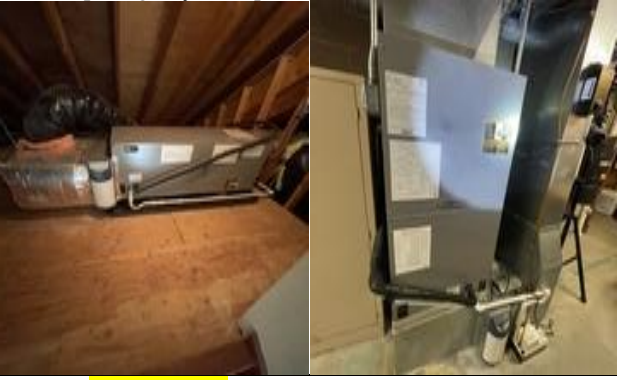
164) . Armstrong CENTRAL A/C Source electric/split system Size 2.5 tons. Apx. Age 2yrs Apx. Life Exp. 15yrs

163) . Trane CENTRAL A/C Source electric/split system Size 2.5 tons. Apx. Age 23yrs Apx. Life Exp. 15yrs	<input type="checkbox"/> <input type="checkbox"/> <input type="checkbox"/>	<p>The Armstrong Air Conditioning System/s are newer installations but could not be inspected/tested because it was too cold outside. The compressor units cannot be operated when it is below 60 degrees without causing damage. Recommend having all units put on an annual service and repair contract with a licensed HVAC contractor. Recommend obtaining all paperwork/warranties for installation and maintenance for your records.</p>

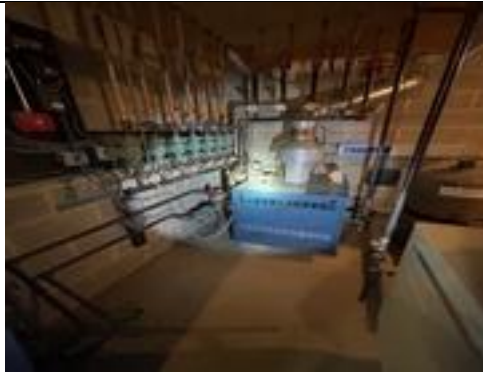
167)	Burnham Hot Water Boiler Gas Fired Apx. BTU's 230,000 Apx. Age 23yrs Apx. Life Exp. 20 to 25yrs	<input type="checkbox"/> <input checked="" type="checkbox"/> <input type="checkbox"/>

<p>The Heating System is older and at the manufactures life expectancy. The unit was functioning at the time of inspection. All units should be serviced, certified and put on an annual service/repair contract with a licensed HVAC contractor. Budget for a replacement when needed.</p> <p>Potable hot water is produced by a tankless coil set into the boiler. It was functioning at the time of inspection.</p>
Plumbing/Pipes Not Fully Visible/Not Fully Evaluated**		S M P

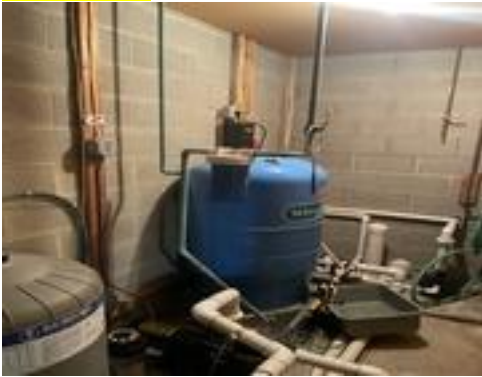
174)	Vent PVC . .	<input checked="" type="checkbox"/> <input type="checkbox"/> <input type="checkbox"/>	
175)	Water Main In Basement .	<input checked="" type="checkbox"/> <input type="checkbox"/> <input type="checkbox"/>

<p>There is a leak on a shutoff valve near the water main in the basement. Needs further evaluation and repair or replacement by a licensed plumber for safety.</p> <p>There is a broken plastic plumbing strap to support the copper water pipe in the front unfinished basement area. Needs repair by a licensed plumber for safety.</p> <p>We did not inspect plumbing waste and associated components. The main sewer pipe exiting the house is underground and not visible or inspected. Note: you are responsible for this pipe and the water main pipe from the street to the house) Recommend having this pipe evaluated/ scoped with a camera by a licensed plumber for safety and condition. Recommend obtaining and maintaining insurance for this pipe which is usually offered by the water company or homeowners' insurance.</p>

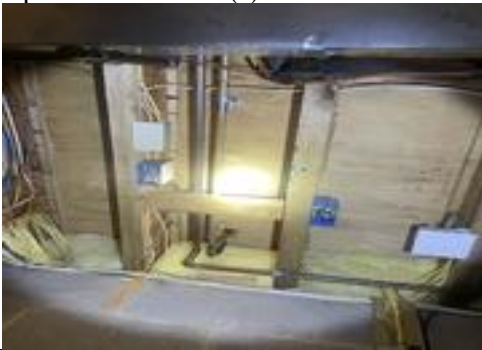
189) Open Junction Box(s) “visible”

There are several open junction boxes in the basement. Needs repair, covers added by a licensed electrician for safety.

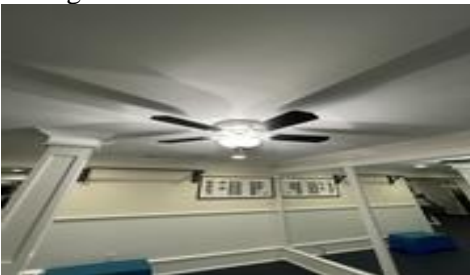
191) Ceiling Fans

There are multiple issues regarding light fixtures and fans in the home. The issues include but are not limited to: One of the fans in the gym was not functioning when tested, the fan in the master bedroom is rubbing when tested and the light in the 2nd floor hallway closet is extremely dim. Needs further evaluation and repairs or replacement by a licensed electrician for safety.

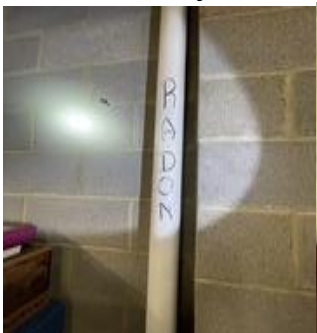
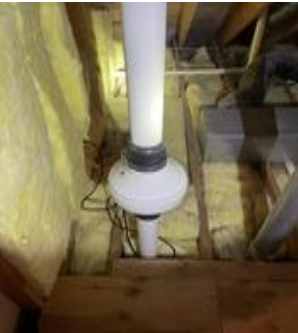
<p>Rs* There appears to be an active radon system for this house. The radon system and all associated components were not fully evaluated. As per the state requirements for home inspection, radon systems are not included. However, it was noted that the manometer monitoring tube is missing from the system and is required. Needs further evaluation and repair by a qualified contractor for safety. Test canisters were placed in the basement to determine the radon levels present. The results of the test will be forwarded to you from the certified laboratory. Recommend obtaining all paperwork, procedures, and maintenance in regard to this system.</p>
